## **Field test comparing frost insulation materials in road construction**

E. Øiseth<sup>1</sup>, R. Aabøe<sup>2</sup> and I. Hoff<sup>3</sup>

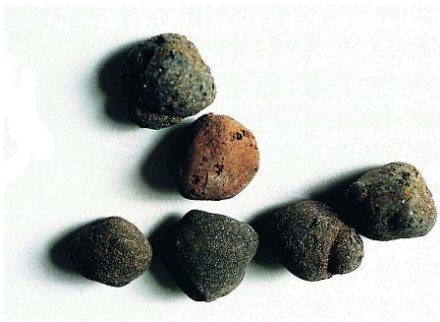
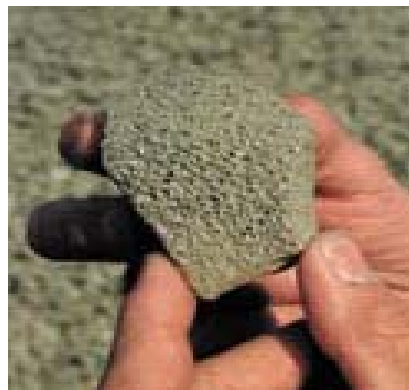
**Figure 1 – Leca LWA to the left, Hasopor foam glass aggregate to the right**

Lightweight clay aggregate (Figure 1 to the left) is used both as lightweight fill and as frost protection in road construction, and the material is also used on a regular basis for other civil engineering application. By sintering clay in a special furnace, hard spheres of various sizes are formed (generally 0 – 32 mm). A typical loose bulk density is approximately 280 kg/m<sup>3</sup>. Average moisture content in pavement structures is found to be 25% by weight (7.7 % by volume). The corresponding thermal conductivity at 10 °C is 0.18 W/mK but it varies significantly with temperature and water content.

Foam glass aggregate (Figure 1 to the right) is produced by recycling waste glass. The foam glass has a maximum grain size of about 60 mm with angular edges and the material may be produced in various densities. A typical loose bulk density is in the range of approximately 180 - 250 kg/m<sup>3</sup>. On recent road projects deformations and possible variations in moisture content, unit density and grain size distribution have been monitored. The moisture content is found to be around 20 % by weight (6 % by volume), corresponding to a thermal conductivity at 10 °C of 0.155 W/mK. The thermal conductivity for foam glass also varies significantly with temperature and water content.

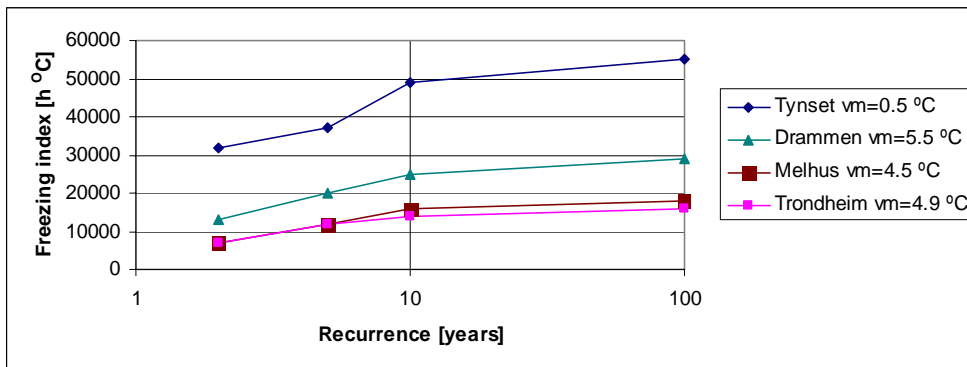
**Figure 2 – Air- freezing index**

Melhus is a place in the middle part of Norway south of Trondheim. Trondheim has a coastal climate, and the climate at Melhus is therefore relatively warm compared to the eastern and northern part of Norway. At Melhus the annual mean temperature is 4.5 °C. The field test sections are part of a new access road build in connection with the new main road E6. The air- freezing index at Melhus for different recurrence frequency are shown in Figure 2 together with some other places in Norway (vm = annual mean temperature).

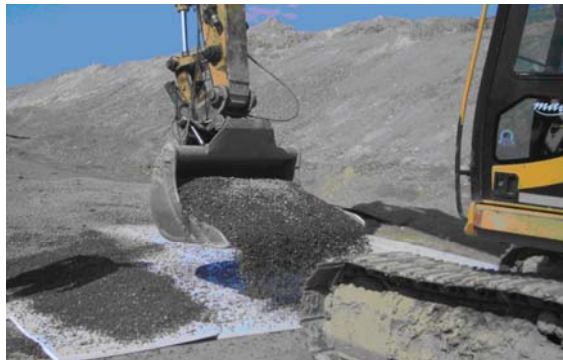
**Figure 4 – Installing XPS insulation boards**

Figures 4 to 7 show the installation of the insulation materials. In Figure 4 the insulation boards are covered gently. In Figure 5 the LWCA surface is leveled and we also see the foam glass to the left. Both the LWCA and the foam glass are compacted after the materials are covered with crushed rock (subbase layer) (Figure 6). Two layers of asphalt constitute the pavement surface (Figure 7).

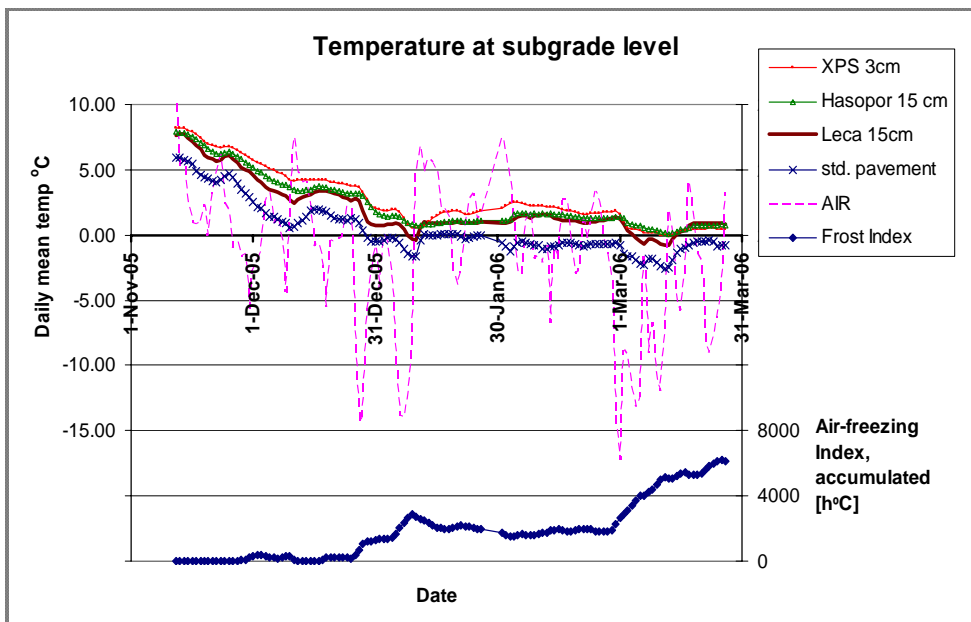
**Figure 8 – Temperature at subgrade level 61 cm below surface**

Figure 8 shows the daily mean temperature at the subgrade level (61 cm below the surface) for all test sections together with the air temperature. The figure also shows the accumulated air-freezing index. The temperature is slightly lower in the section with LWCA (Leca) than in the sections with foam glass (Hasopor) and XPS boards. Around March 13<sup>th</sup>, 2006 the temperature is at the freezing point below the foam glass layer and the XPS layer corresponding to about 5100 h°C (air). The frost penetrated the LWCA layer some 10 days earlier (for the second time this winter) corresponding to about 3700 h°C (air). The measurements are indicating that the frost insulating capacity for the structure may be somewhat lower than estimated.

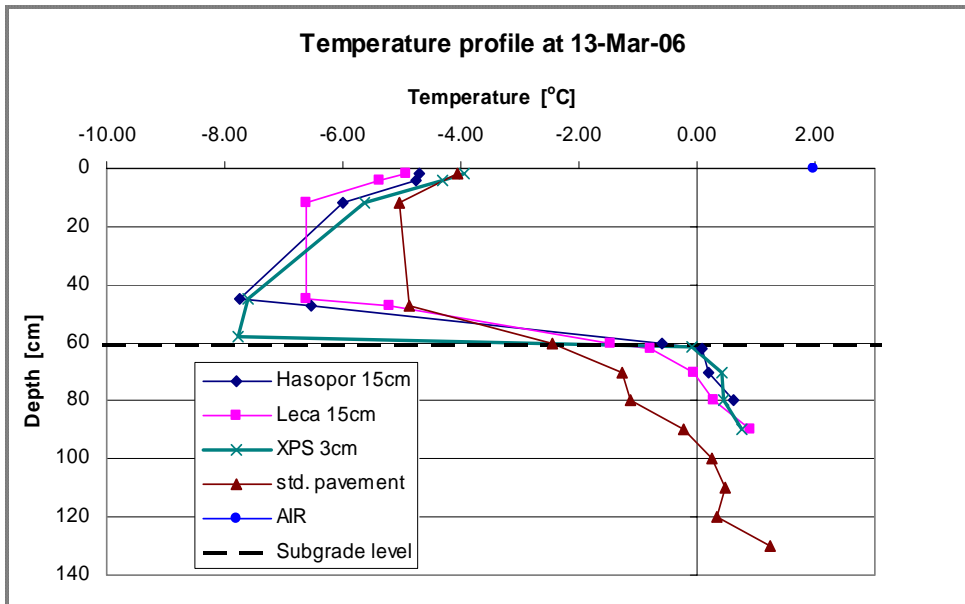
**Figure 9 – Temperature profiles at March 13<sup>th</sup>, 2006.**

Figure 9 shows the temperature profiles for the different sections at March 13<sup>th</sup>. From this we see that the frost had penetrated almost 10 cm into the subgrade at the Leca LWA section and about 35 cm into the subgrade at the section without insulation.
